THE STREAMBANK EROSION CONTROL EVALUATION AND DEMONSTRATION ACT OF 1974 SECTION 32, PUBLIC LAW 93-251

Appendix G - Demonstration Projects on Other Streams, Nationwide Volume 2 of 2

APPENDIX G DEMONSTRATION PROJECTS ON OTHER STREAMS, NATIONWIDE

A BRIEF SUMMARY REPORT AND INDIVIDUAL EVALUATION REPORTS ON TWENTY STREAMBANK EROSION CONTROL DEMONSTRATION PROJECTS ON SIXTEEN DIFFERENT STREAMS THROUGHOUT THE UNITED STATES

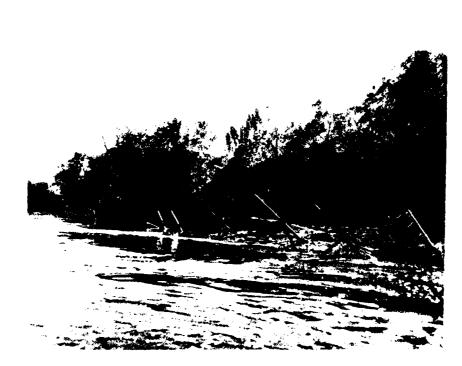
PHOTO 3. STEEL JACKS IN PLACE AFTER CONSTRUCTION.

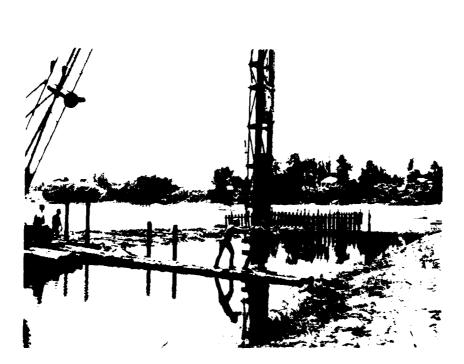
PHOTO 5. TIMBER JETTIES DURING CONSTRUCTION. 24 AUGUST 1978.

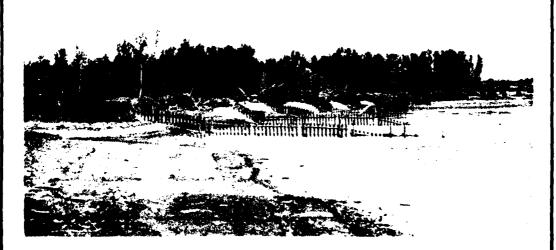
PHOTO 6. LOOKING UPSTREAM FROM STA 18+00 AT TIMBER JETTIES. 19 OCTOBER 1978.

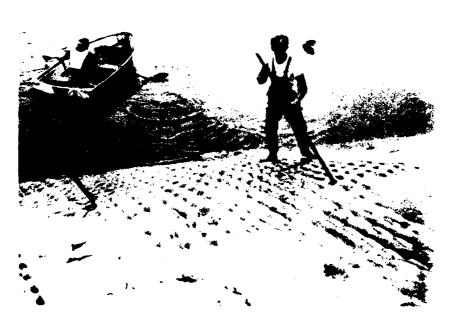
PHOTO 8. PUMPING GROUT INTO THE EROSION CONTROL MAT. 24 AUGUST 1978.

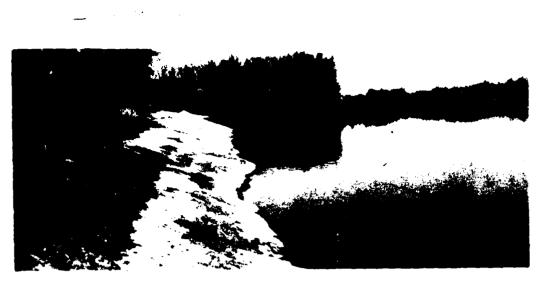
PHOTO 9. STA 12+00 LOOKING UPSTREAM AT CONCRETE MAT. 14 NOVEMBER 1979.

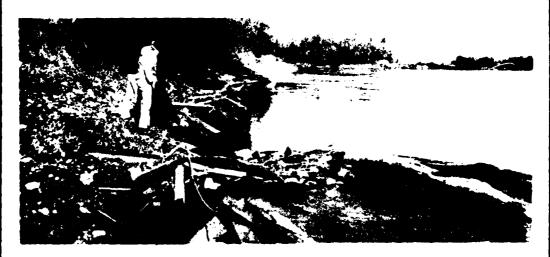
- 12. Evaluation of Protection Performance. Flooding in the spring of 1979 resulted in some damage to timber jetties and to the steel jacks. This damage is shown in photos 10 and 12 as mentioned previously.

The erosion control mat and timber jetties protection has been effective in reducing additional bank erosion. The steel jacks, however, were not as effective as planned. This is probably due to two conditions. One, water and ensuing debris are moving too fast when they strike the steel jacks. Steel jacks operate better in catching debris and deflecting the current when the water is at a lower velocity. Second, ice lifting and heaving resulted in some of the steel jacks being flattened and moved from their original position in the river to a flattened position on the bank.

PHOTO 12. STA 6+00 LOOKING UPSTREAM AT DAMAGED STEEL JACKS. 14 NOVEMBER 1979.

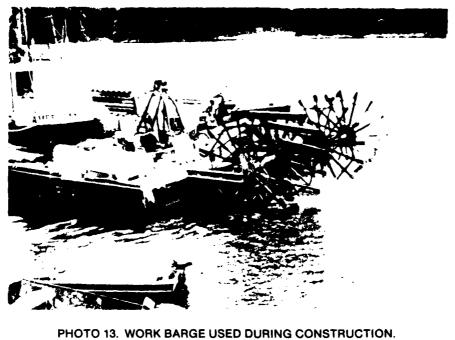
PHOTOS 13 AND 14

- 11. Rock Island District is now monitoring this project four times a year, including yearly surveys. Photo 10 is an example of the damage to the timber jetties. Some panels are bent or missing. Some panels were probably lifted off by ice action. Photo 11 illustrates some spalling on the surface of the erosion control mat, apparently the aftermath of a fisherman's campfire. The fabric covering of the erosion control mat has been cut by the jacks or cables in a few places. A break in the concrete erosion control mat was noted in April of 1981. The break is about 3 to 5 feet long. A knife blade could penetrate the break to about 1/2 inch, although the break is obviously the total depth of the mat. See photo 14. However, other than these minor problems, the fabric is in good condition. Photo 12 illustrates the damage to the steel jacks on the upstream end. The anchor cable securing these upstream jacks was broken during ice flow conditions.

PHOTO 14. BREAK IN CONCRETE EROSION CONTROL MAT.

- 13. Rehabilitation. Rock Island District personnel from Operations Division did repair work on the timber jetties during the summer of 1980. This work consisted of repairing or replacing damaged and broken wood panels and welding pipe extensions to some of the pipe piling. This work was completed at a cost of \$16,106.20. The broken cable previously mentioned was extended and anchored by Rock Island District personnel to a tree growing near the top of the riverbank. The cost of this repair work was \$400.

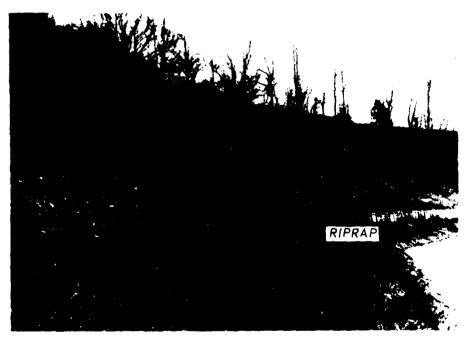
PHOTO NO. 4. Completed project showing unstable condition of upper bank. This bank is expected to gradually stabilize at its natural angle of repose.

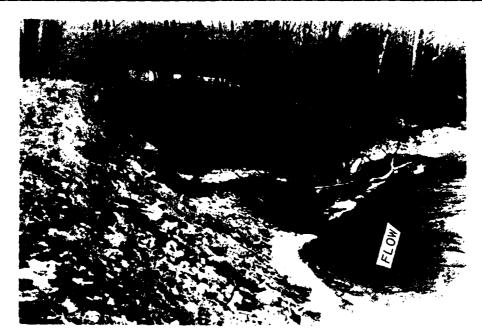
PHOTO NO. 5. 5 Jan. 81. Erosion downstream end of project. Repair of this transition to natural section will be required.

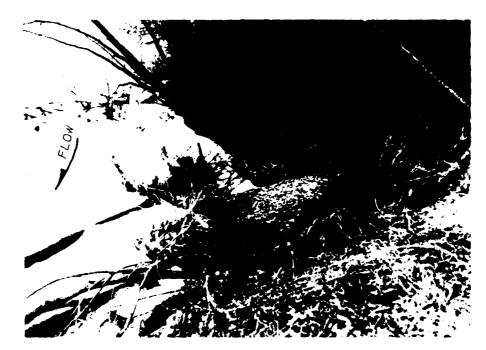
PHOTO NO. 6. Jan 81. Erosion upstream end of project. Transition repair will be required here also.

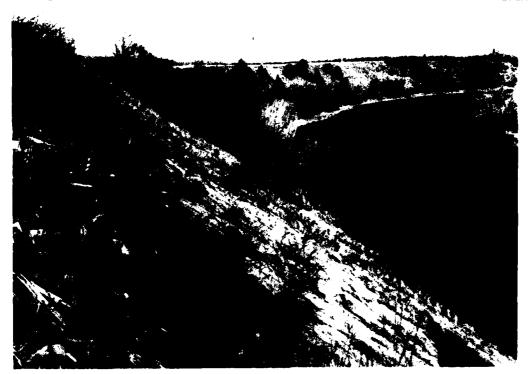
PHOTO 1. SITE NO. 3 - HIGH, LOOKING UPSTREAM, BANK ABOUT 100 FEET HIGH, 30 OCTOBER 1980.

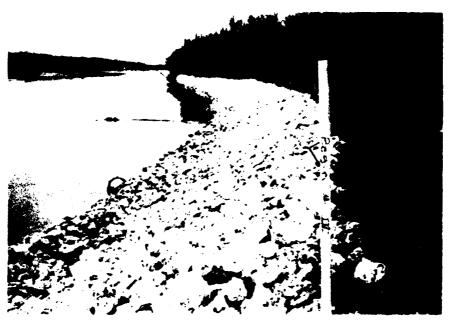
PHOTO 7. SECTION 4 LOOKING UPSTREAM AFTER CONSTRUCTION. 17 NOVEMBER 1980.

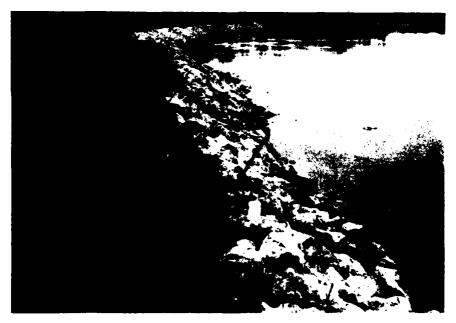
PHOTO 9. SECTION 5 LOOKING DOWNSTREAM AFTER CONSTRUCTION. 17 NOVEMBER 1980.

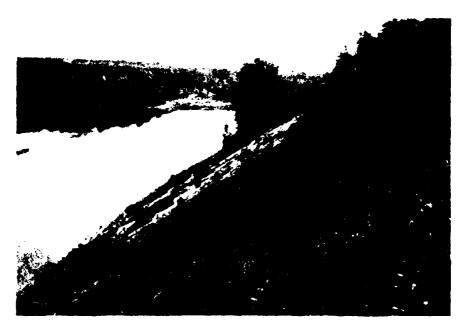
PHOTO 33. LOOKING DOWNSTREAM BEFORE CONSTRUCTION. 27 AUGUST 1980.

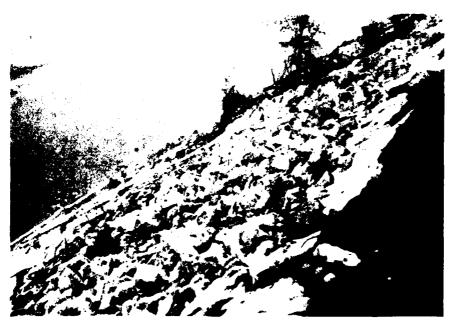
PHOTO 34. LOOKING DOWNSTREAM AFTER CONSTRUCTION. 5 DECEMBER 1980.

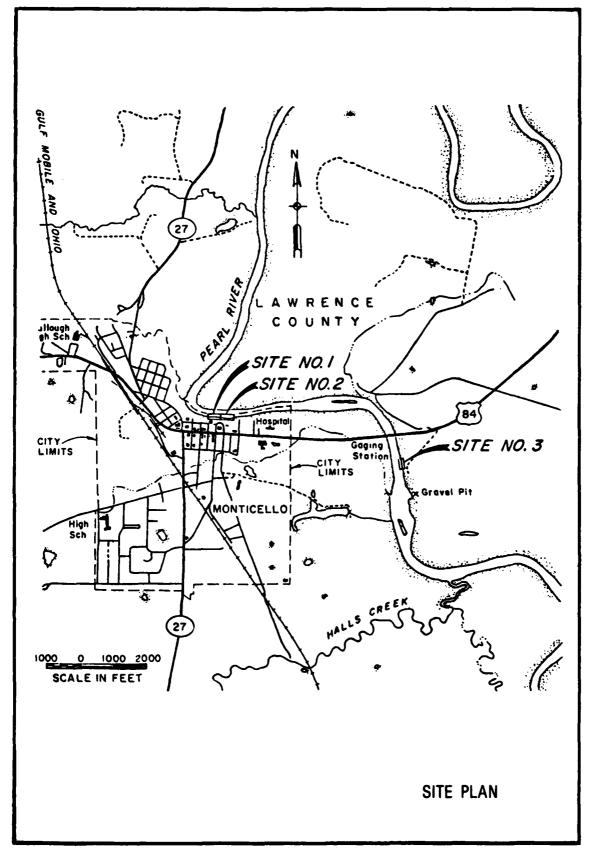
PLATE 2

- 8. <u>Channel Conditions</u>. Sites 1 and 2 shown on Plates 2 and 3 are on the outside of a 135⁰ bend situated on a bank 25-30 feet above low water. Site 3 (Plate 4) is on the outside and downstream of a 90⁰ bend on a bank which extends approximately 8 feet above low water. The upstream bend, near Sites 1 and 2, is characteristic of "abrupt angle" bends wherein the majority of the current attack is concentrated on

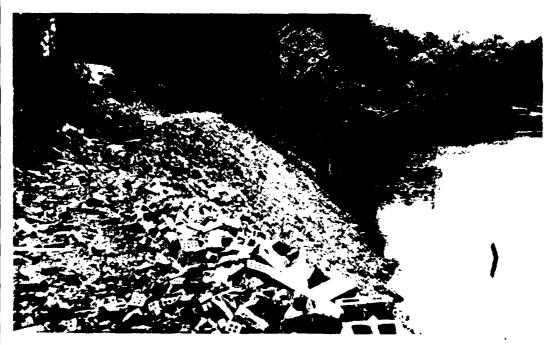
AFTER FLOOD OF MAY 1981. NOTE UPSTREAM VIEW, TOP OF RUBBLE 190 FEET N.G.V.D., 18 FEET ABOVE WATER SURFACE.

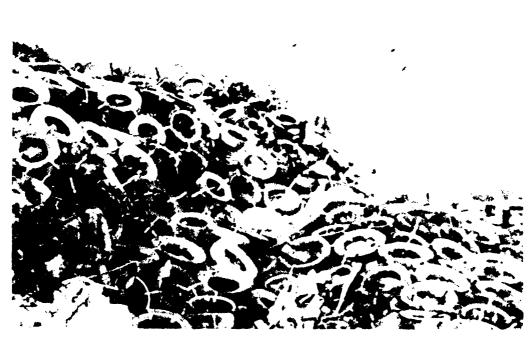
AFTER CONSTRUCTION, DECEMBER 1980. NOTE FLOW TO THE RIGHT, TOP OF STRUCTURE 190 FEET N.G.V.D., 23 FEET ABOVE WATER SURFACE.

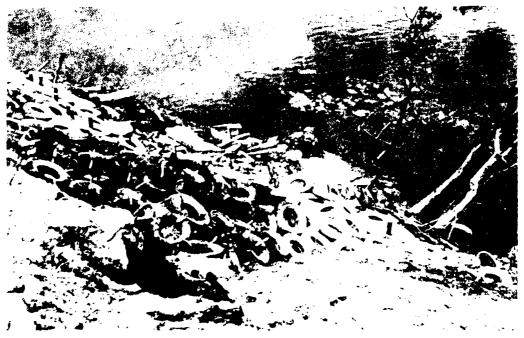
AFTER FLOOD OF MAY 1981. NOTE FLOW TO THE RIGHT, TOP OF STRUCTURE 190 FEET N.G.V.D., 18 FEET ABOVE WATER SURFACE.

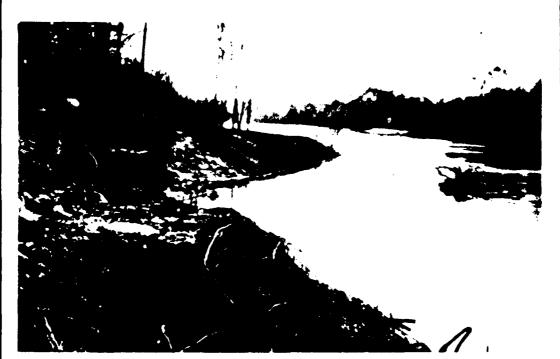
AFTER CONSTRUCTION, DECEMBER 1980. NOTE DOWNSTREAM VIEW, TOP OF STRUCTURE 180 FEET N.G.V.D., 8 FEET ABOVE WATER SURFACE.

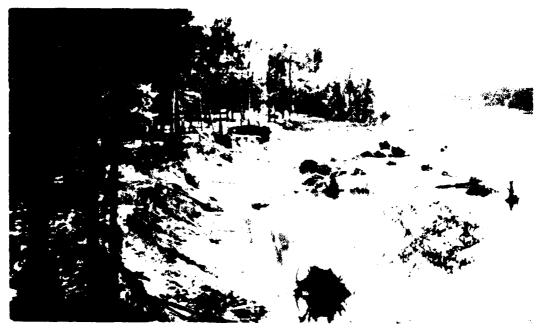
AFTER FLOOD OF MAY 1981. NOTE DOWNSTREAM VIEW, TOP OF STRUCTURE 180 FEET N.G.V.D., 13 FEET ABOVE WATER SURFACE.

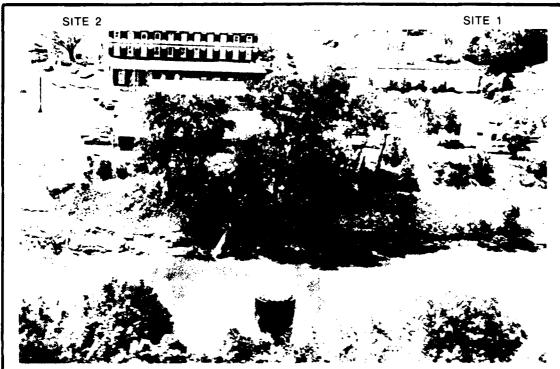
SITES 1 AND 2. MAY 1981. NOTE FLOW TO THE LEFT, TOP OF BANK APPROXIMATELY 200 FEET N.G.V.D., 33 FEET ABOVE WATER SURFACE.

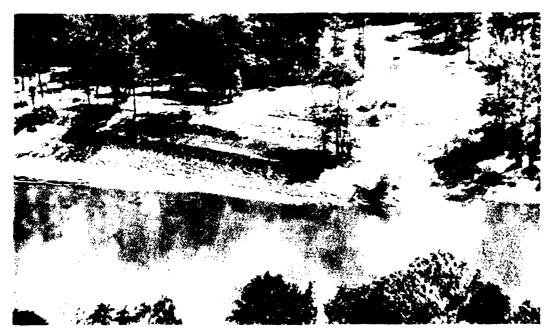
SITE 3, MAY 1981. NOTE FLOW TO THE RIGHT, TOP OF BANK APPROXIMATELY 185 FEET N.G.V.D., 18 FEET ABOVE WATER SURFACE.

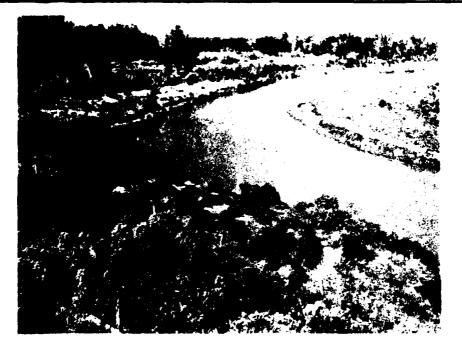
PHOTO I LOOKING DOWNSTREAM BEFORE CONSTRUCTION DATE: OCT 1980

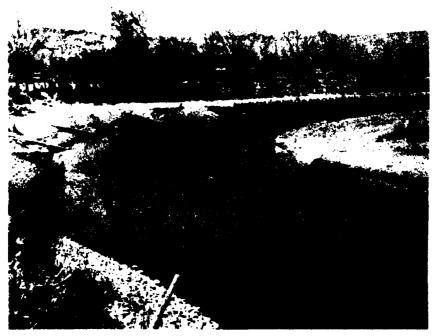
PHOTO 2 LOOKING UPSTREAM AFTER CONSTRUCTION DATE: APRIL 1981

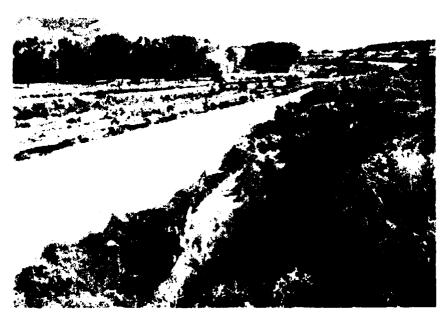
PHOTO I LOOKING DOWNSTREAM BEFORE CONSTRUCTION DATE: OCT 1980

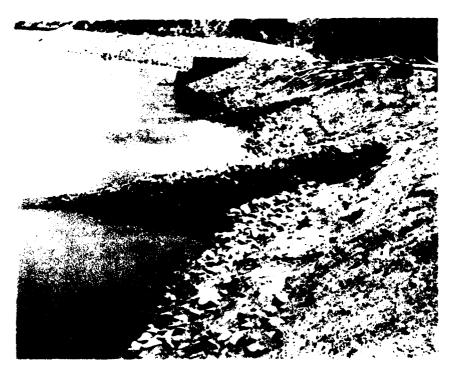
PHOTO 2 LOOKING DOWNSTREAM AFTER CONSTRUCTION DATE: APRIL 1981

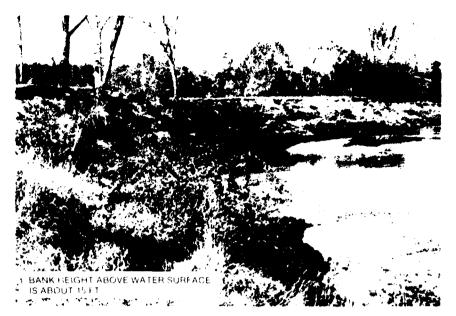
PHOTO 5. Site A, Station 5+00, downstream 24 Oct 79

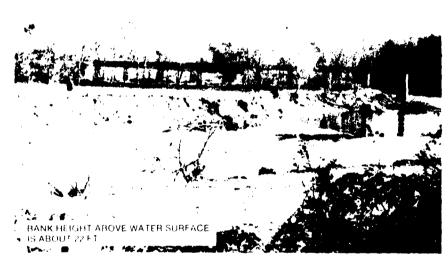
PHOTO 6. Site C, Entire site viewed from across river 24 Oct 79

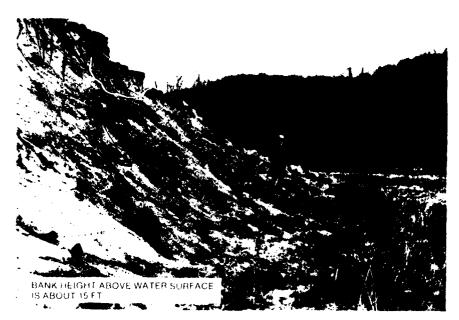
PHOTO 7. Site A, Station 2+50, downstream 27 Feb 80

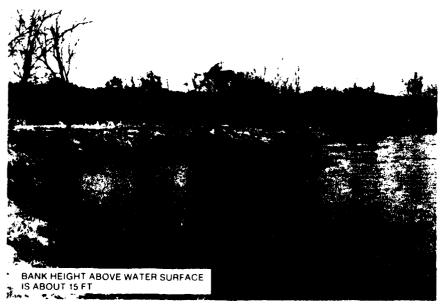
PHOTO 8. Site A, Station 4+50, downstream 27 Feb 80

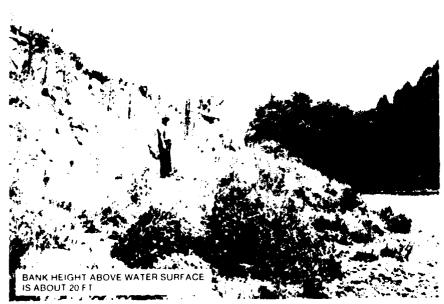
PHOTO 10. Site A, Station 2+50, downstream 3 Sep 80

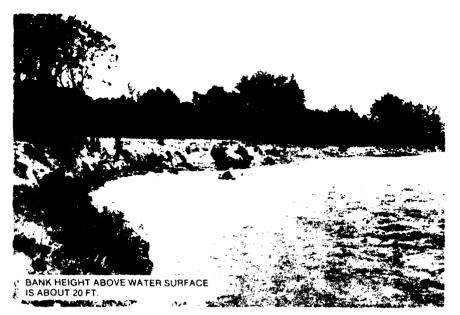
PHOTO 11. Site A, Station 4+50, downstream 3 Sep 80

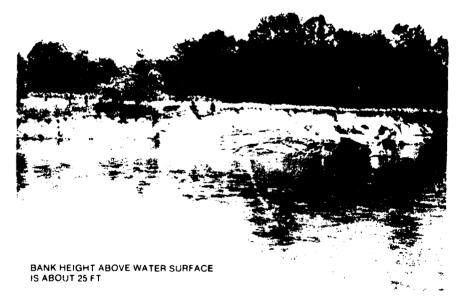
PHOTO 12. Site C, Station 4+00, near center of Site C from across river 3 Sep 80

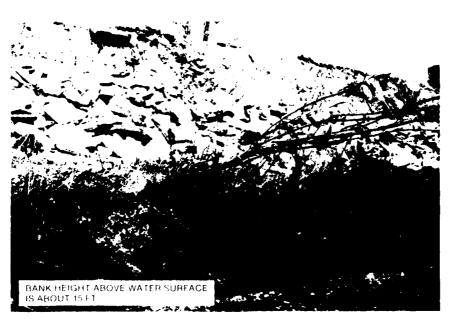
PHOTO 13. Site A, Station 3+50, view of bank, stone rubble method 5 Jan 81

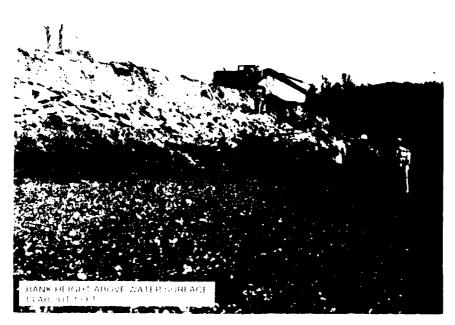
PHOTO 14. Station 3+50, downstream, stone rubble method 5 Jan 81

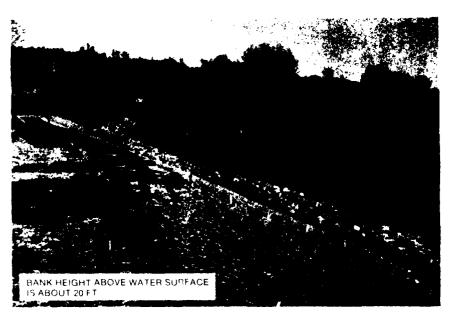
PHOTO 15. Site A, Station 4+00, downstream, completed stone rubble (foreground), beginning tire mattress-rock toe 5 Jan 81

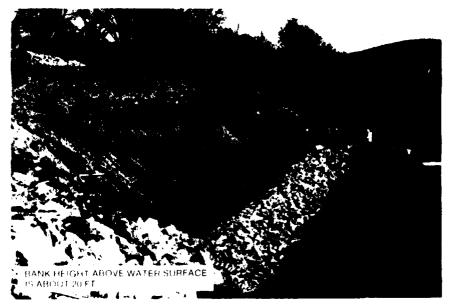
PHOTO 16. Site A, Station 6+50, downstream, showing transition from rubble to tire mattress-rock toe method (background) 5 Jan 81

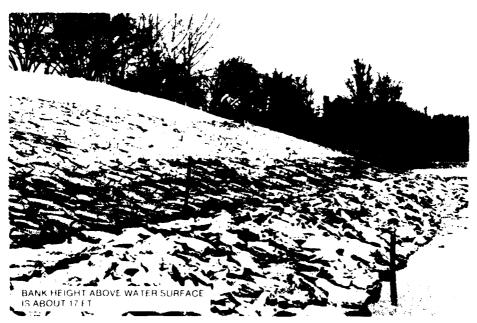
PHOTO 18. Site A, about Station 9+00. View of rubber tire mattress - rock toe immediately after construction. 21 Mar 81

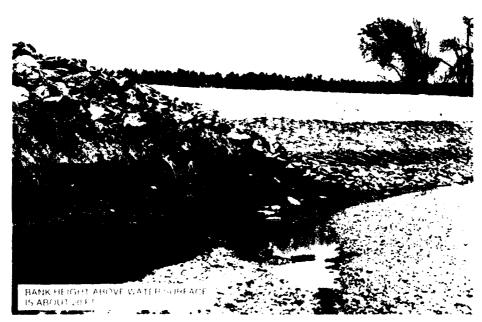
PHOTO 19. Site A, Station 7+00, downstream. Transition from stone rubble to tire mattress - rock toe immediately after construction. 21 Mar 81

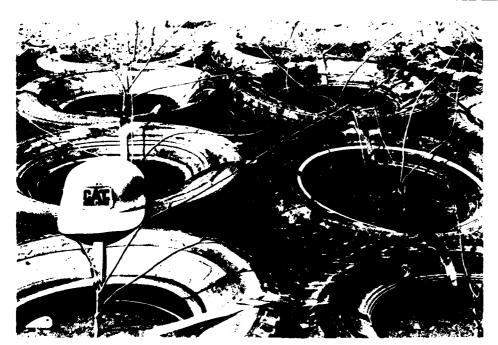
PHOTO 20. Site A, close-up of rubber tire mattress immediately after construction. 21 Mar 81

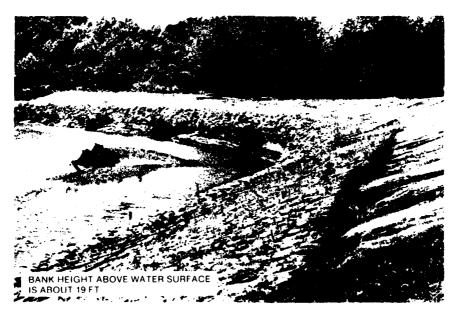
PHOTO 21. Site A, view upstream, standing at Station 8+00, curve and tree stump at Station 7+00 (transition from stone rubble to rubber tire mattress with photo coverage to Station 5+00, 2 months after construction. 21 May 81

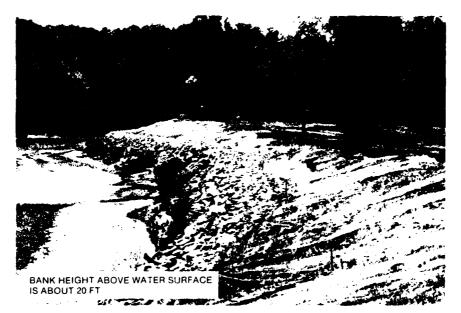
PHOTO 22. Site A, view upstream from Station 6+00 to 2+00, stone rubble method, 2 months after construction. 21 May 81

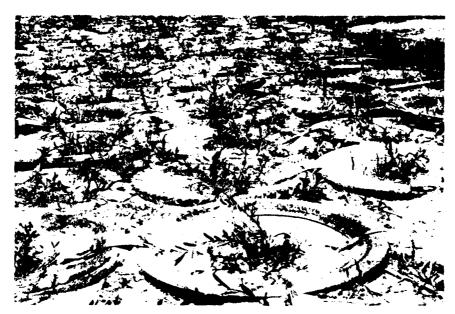
PHOTO 23. Site A, close-up of rubber tire mattress 2 months after construction. 21 May 81

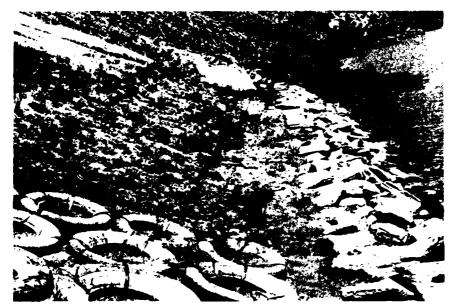
PHOTO 24. Site A, downstream view, Station 12+50 to 13+00 showing lower 50 feet of project that received only rock toe and grass cover (no tires). 21 May 81

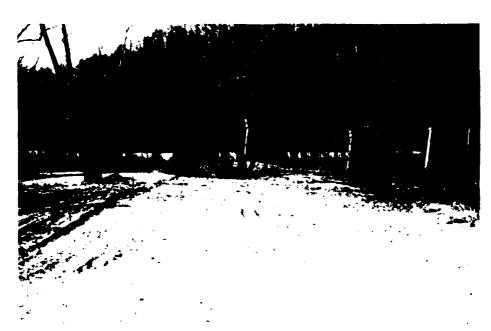
PHOTO 25. Site C, stone windrow method. Upstream view from Station 3+00 to 0+00. River on right. Immediately after construction. 21 May 81

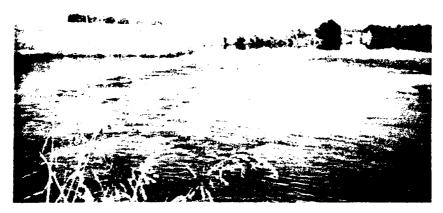
BEFORE CONSTRUCTION

Station 22+60 in center of photo - Looking upstream - Bank height about 20 feet (January 1980)

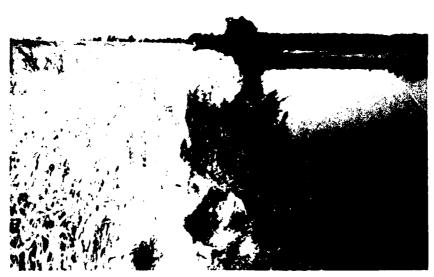
BEFORE CONSTRUCTION

Station 22+60 - Looking upstream at limits of vegetative planting (January 1980)

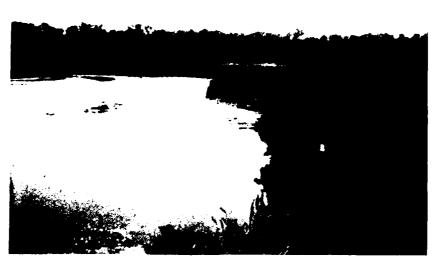
BEFORE CONSTRUCTION

Station 22+60 - Looking downstream at area for concrete pile groins (January 1980)

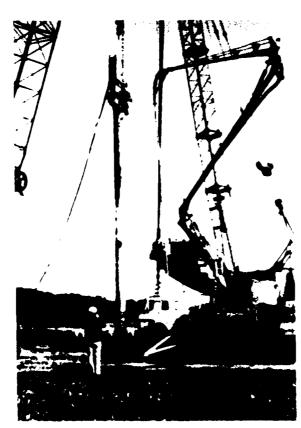
DURING CONSTRUCTION

Drilling of 2' # holes for piles - Note the use of two cranes (December 1980)

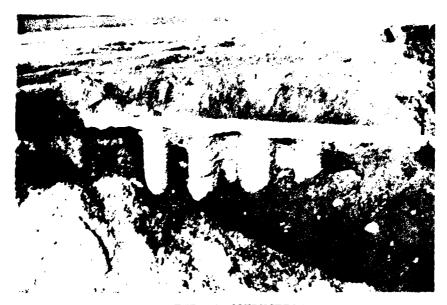
AFTER CONSTRUCTION

Station 18+20 - Looking at downstream side of groin Number 14 - Erosion to a depth of 10 feet (April 1981)

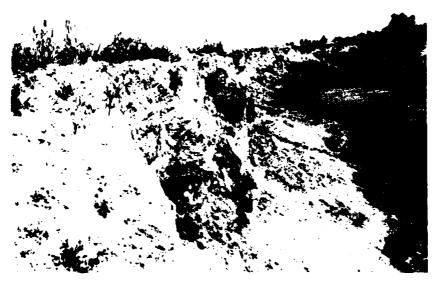
AFTER CONSTRUCTION

Station 17+40 - Looking upstream at groin Number 17 (April 1981)

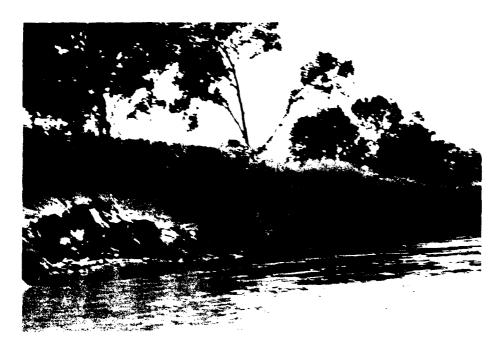
PHOTO 2

STA 11+00

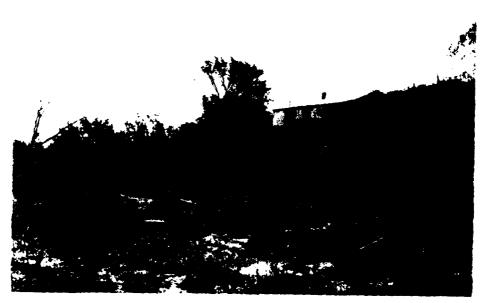
PHOTO 3

PRE-PROJECT CONDITIONS

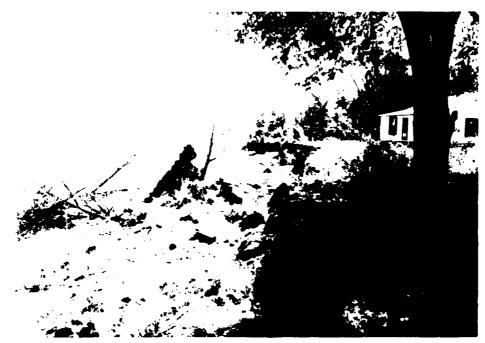
PHOTO 4

PRE-PROJECT CONDITIONS

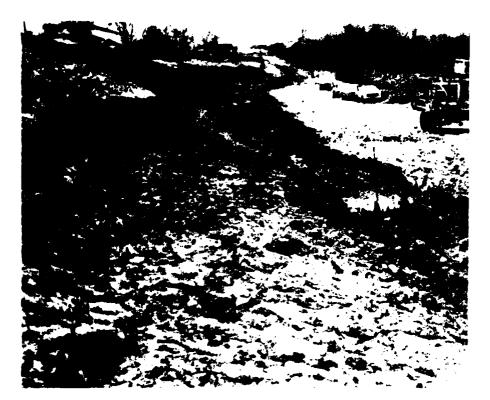
PHOTO 5

VIEW UPSTREAM

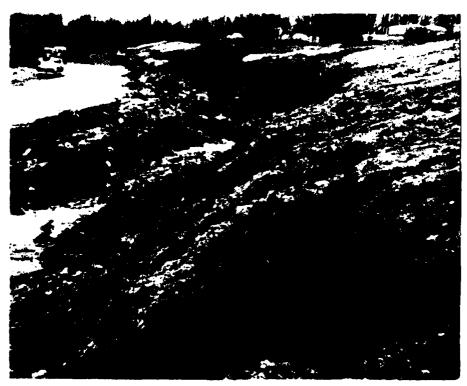
PHOTO 6

VIEW DOWNSTREAM
BANK FAILURE AFTER GRADING

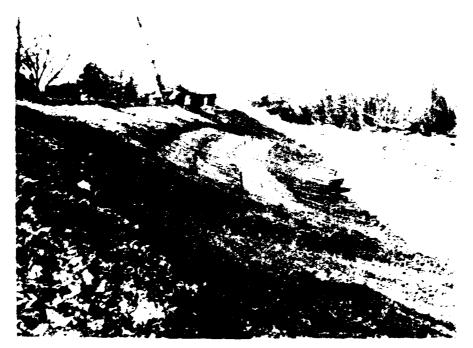
PHOTO 7

VIEW UPSTREAM

REPLACING FAILED BANK MATERIAL WITH
SEMI-COMPACTED CLAY GRAVEL

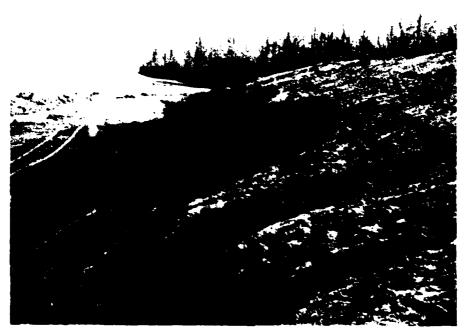
PHOTO 8

VIEW DOWNSTREAM

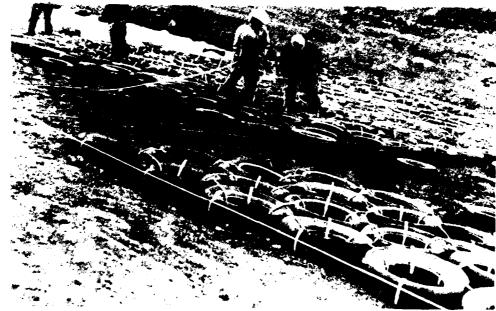
PHOTO 11

PLACEMENT AND ANCHORAGE OF USED TIRES

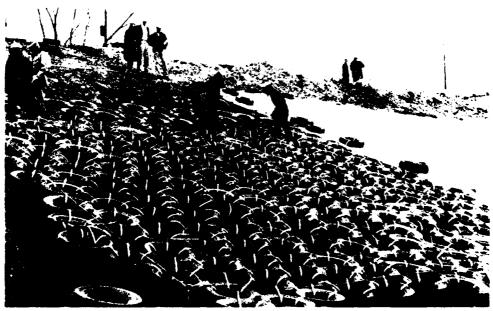
PHOTO 12

USED TIRE REVETMENT

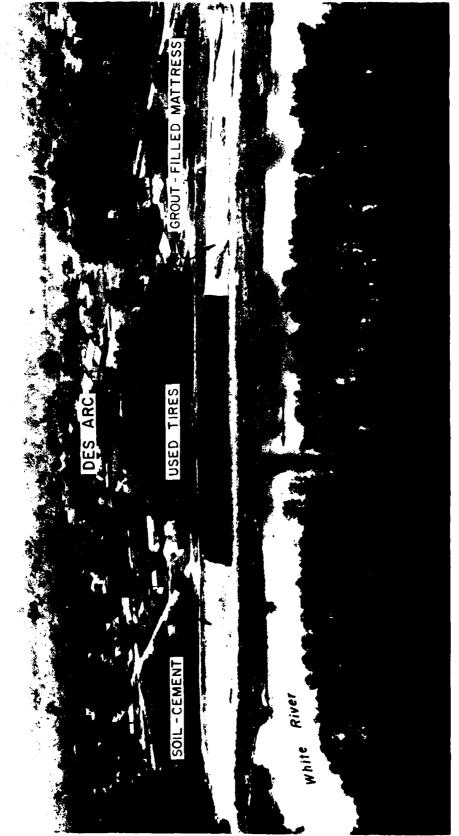
PHOTO 14

VIEW OF COMPLETED PROJECT SHOWING 3 TYPES OF BANK PROTECTION

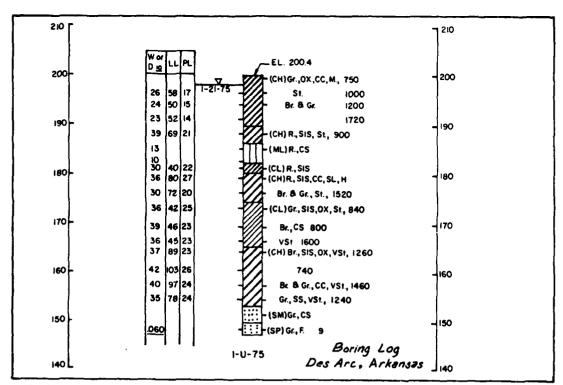
INCLOSURE 4

- 6. As stated, the bank caving should continue until an equilibrium condition is reached. The limits to which caving may be expected is shown on Inclosure 4. It should be noted that the location of the limits are nothing more than a guess on our part. On reaching a slope of equilibrium it cannot be assumed that the banks are permanently stabilized. With the recurrence of erosion at the toe of the talus, the failure mechanism may be again generated. This is not an unlikely event but rather an expected natural occurrence.

- 7. There are several remedial measures which may be undertaken to stabilize the bank section. Those which are thought to meet with the most success will necessitate the placement of large quantities of stone. (A massive rock toe, bank grading and paving or a system of stone dikes and bank grading and some paving). It is not felt that the work allowed under the Streambank Erosion Control Evaluation and Demonstration Act of 1974 will be adequate to stabilize the banks. If the failure mechanism is similiar to that described the placement of erosion protection on the bank surface will not be adequate to stabilize the banks. It should be carefully noted that the described failure mechanism is merely a conjecture on our part. Before any course of remedial action is taken, it is recommended that
